## Section 8

### *Characterisation of the Avoca/Vartry Catchment Area*

#### 8.1 Driving Forces and Pressures in the Avoca/Vartry Catchment Area

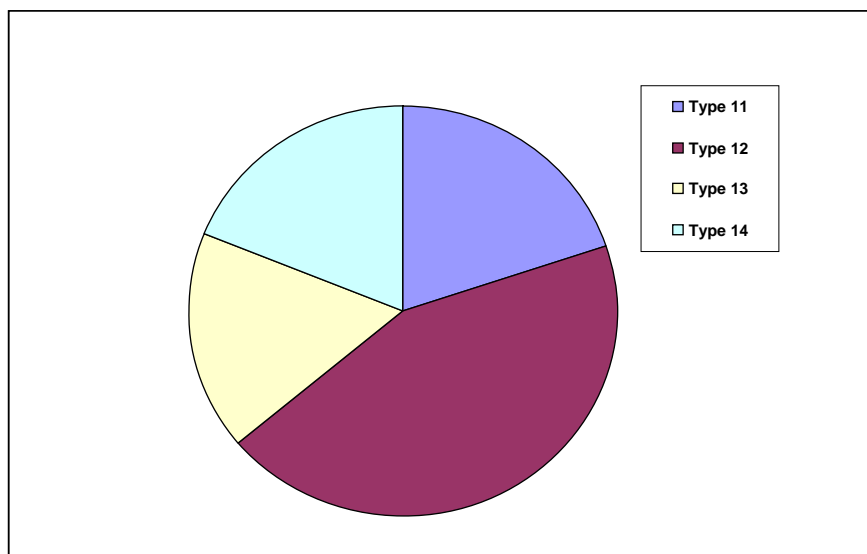
**Figure 8.4: River Typologies (HA10)**

The Avoca/Vartry catchment area contains 360.5 km of river channels designated as falling within WFD criteria for water bodies, covering 1,138.1 km<sup>2</sup>. A total of 78 river water bodies have been identified in the Avoca/Vartry catchment area. These water bodies are shown in **Figure 8.3** and are listed in **Table D.3 of Appendix D**. The most common typology categories, as defined in **Section 4.3.2**, are Type 12 (44%) with Type 11, 13 and 14 all having similar representations of around 20%. Types 2 and 3 rivers are not present, reflecting the siliceous geology. The type distributions are shown in **Figure 8.4**.

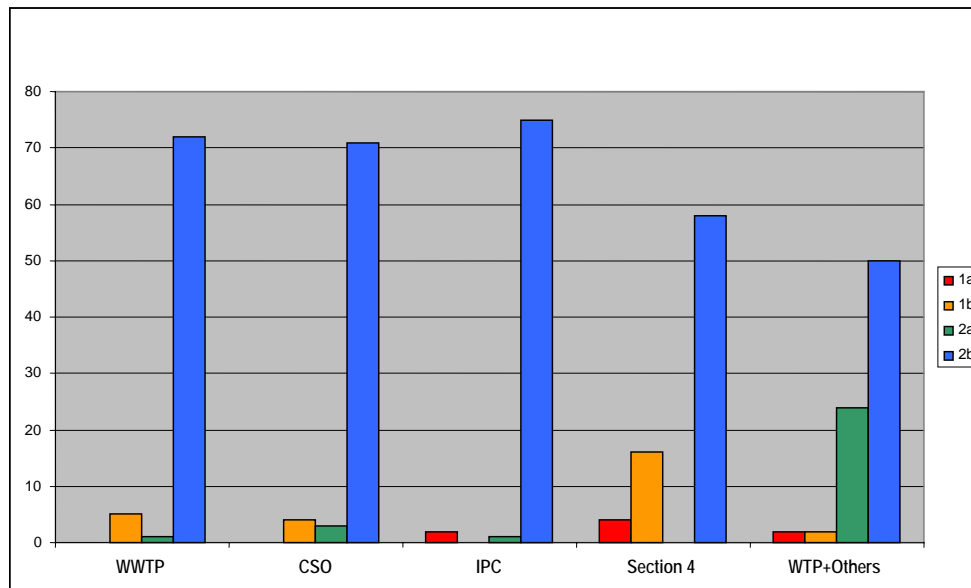
**Figure 8.8: Point Sources (HA 10)**

**Figure 8.8** shows the risk status as affected by point sources. As in the neighbouring Liffey, they are not as significant as general diffuse sources and morphology in terms of risk, with a total of 5 water bodies classed as 1a and 16 as 1b risk class. This gives a total of 21 water bodies experiencing some risk, which translates to 27% of water bodies (**Figure 8.9**).

The most significant point sources are Section 4 discharges, in terms of overall risk, with 4 water bodies rated as 1a and 16 as 1b. Many of these discharges are package sewage treatment plants from rural communities, hotels and businesses not served by mains sewer. IPC discharges account for 2 water bodies being rated as 1a, and WTP and “others”, which include mines, quarries and tip sites, account for 2 water bodies rated 1a, and 2 rated 1b. These at risk water bodies are as a result of the Avoca mines.

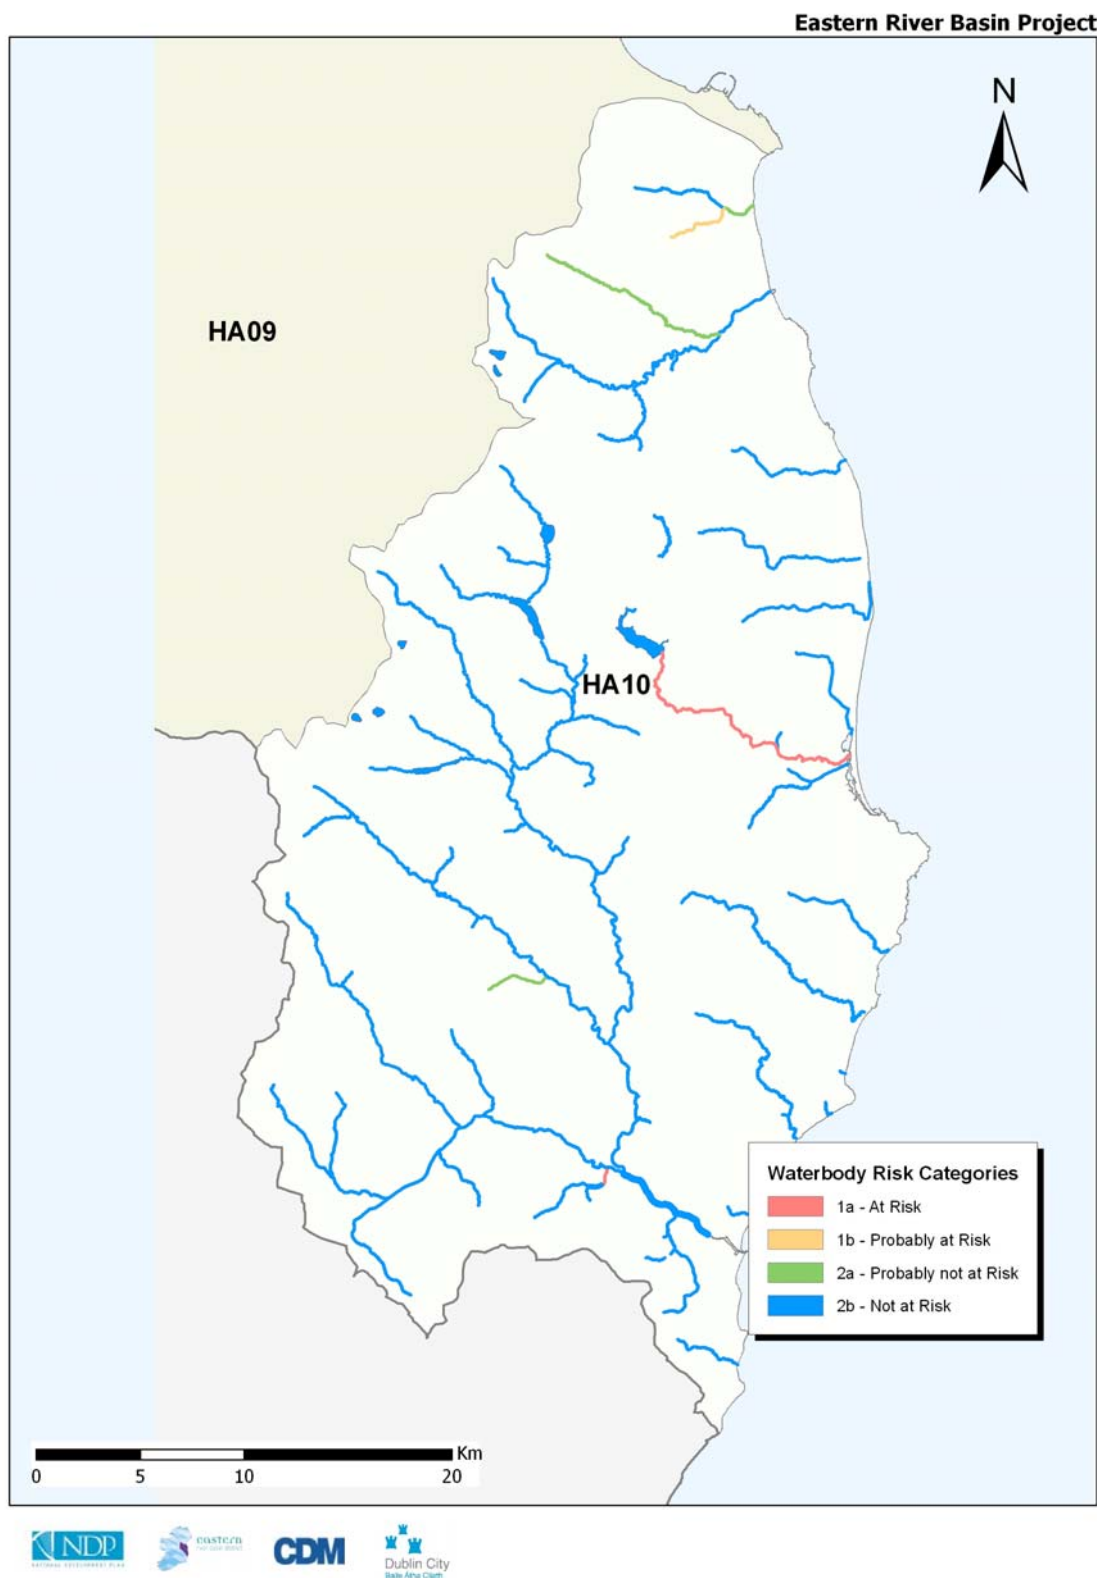
Figure 8.10: Hydrological Risk (HA10)

Three water bodies were characterised as being 1a (“At Risk”) from hydrological pressures. i.e. abstraction, and 1 as 1b (“Probably At Risk”) (**Figure 8.10**). The 1a/1b water bodies include the Vartry and the Goldmine River.

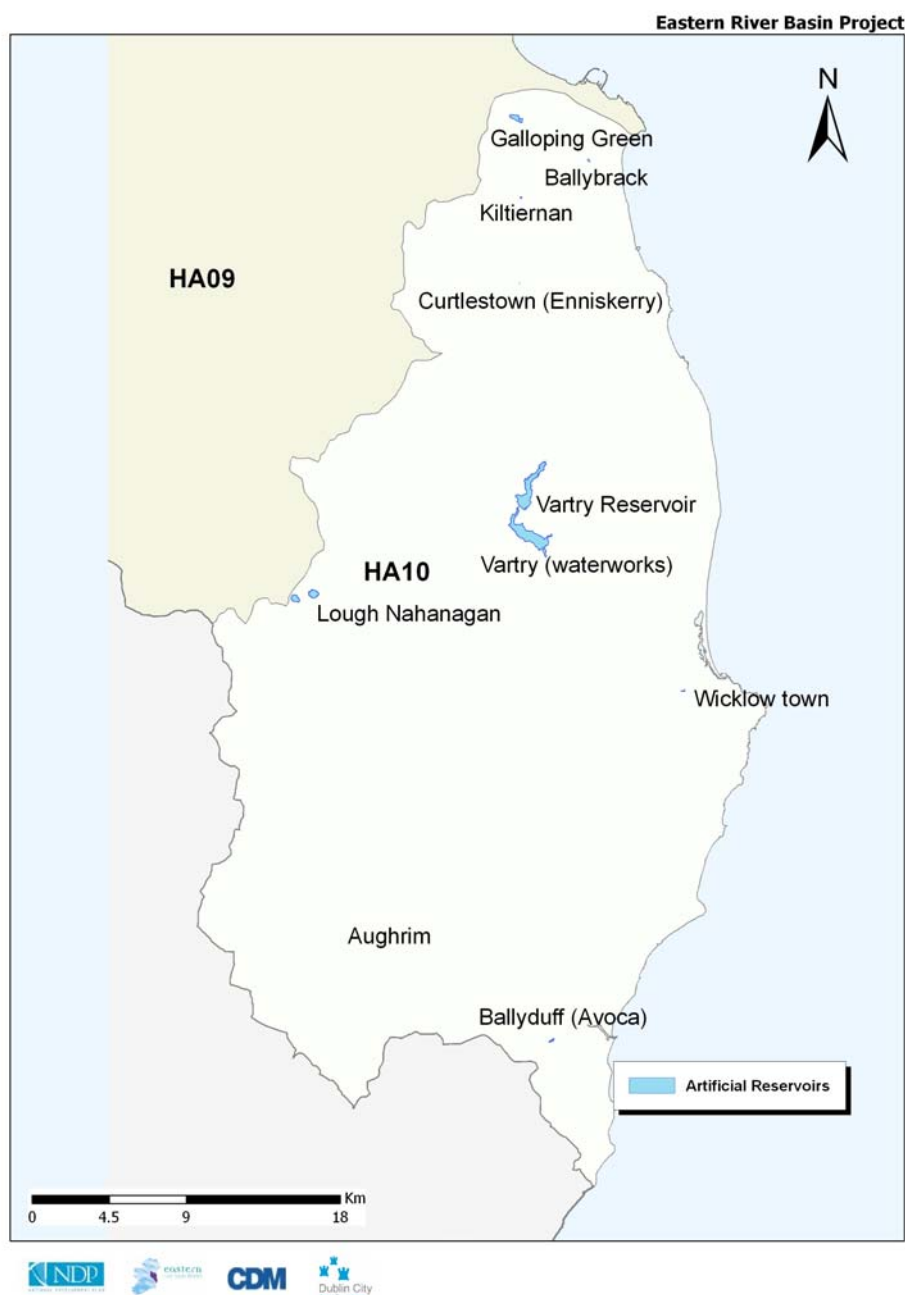
Figure 8.13: Artificial Water Bodies (HA10)

There are no designated AWB's in HA10. Constructed reservoirs in HA10 are shown in **Figure 8.13**.

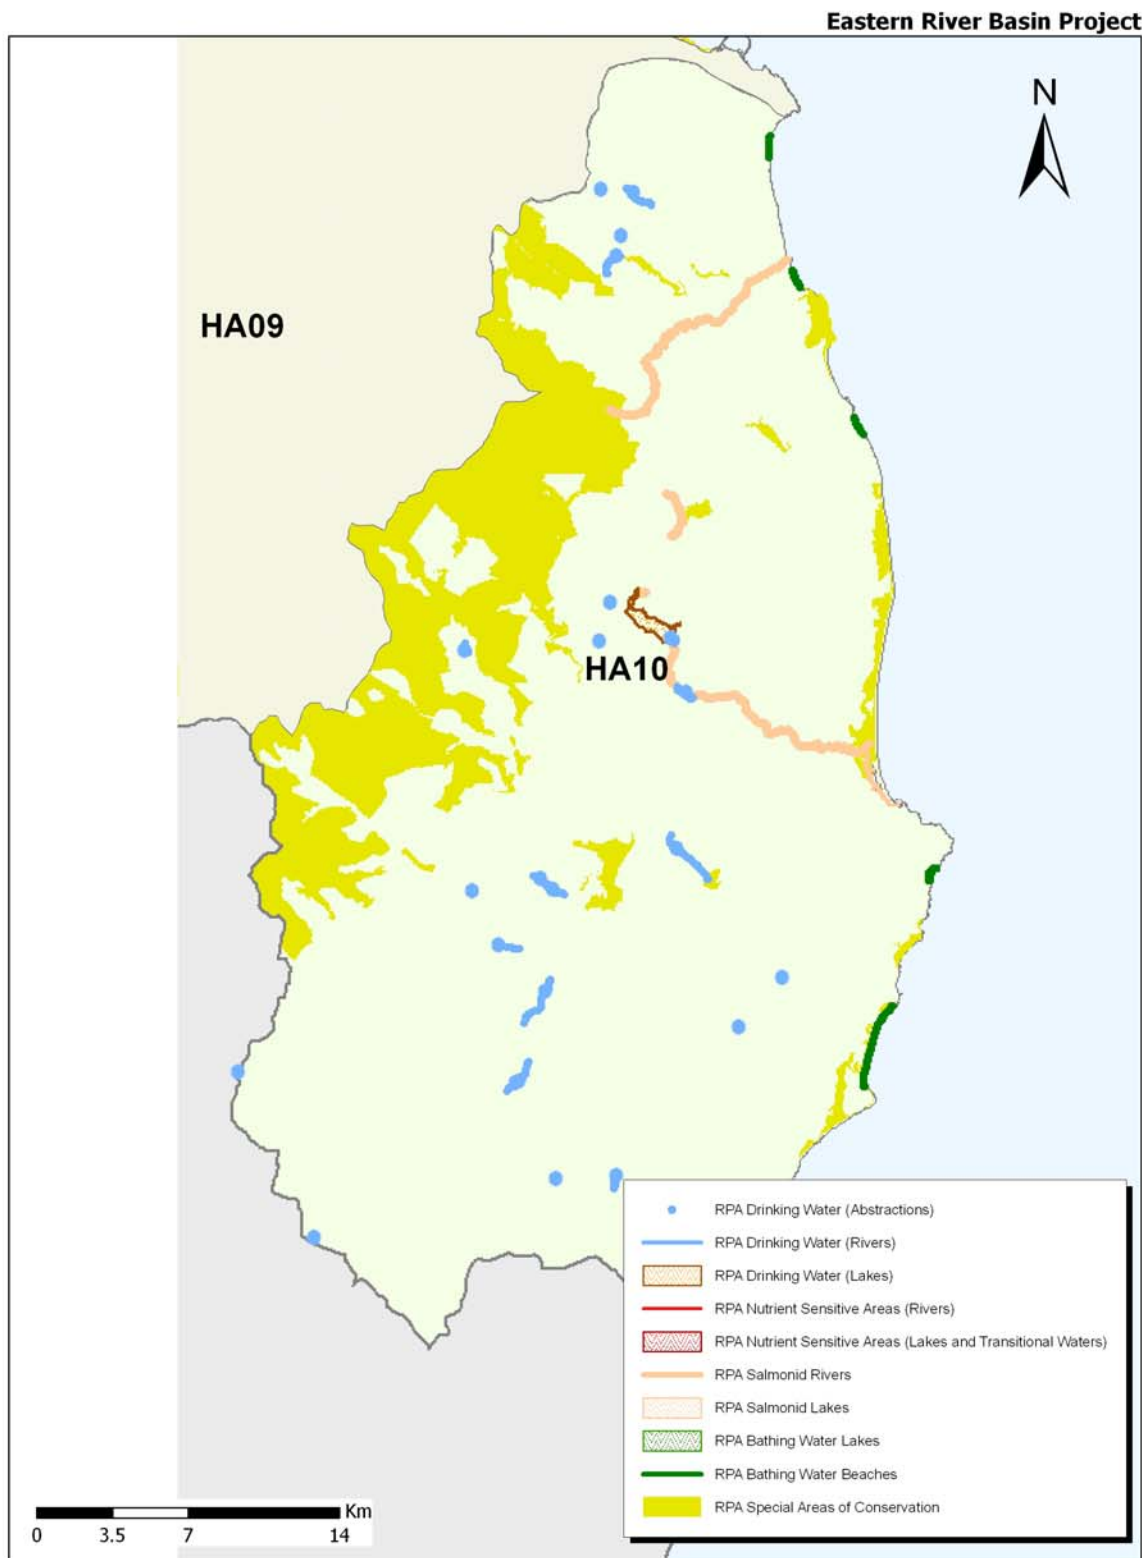
Figure 8.14: Protected Areas (HA10)

A total of 14 water bodies have been designated as protected areas on the basis of abstraction protection as shown on **Figure 8.14**. These are also listed in **Appendix D-7**. These protected areas include 1 lake, 3 ground waters and 10 rivers. Of these, 7 are "At Risk", 2 are "Probably At Risk", 4 are "Probably Not At Risk" and one "Not At Risk".

A total of 8 water bodies have been designated as Salmonid waters. They are found on the Dargle and Vartry Rivers and include one transitional and seven river water bodies as shown in **Figure 8.14**. Five are "At Risk", 1 "Probably At Risk" and 2 "Probably Not At Risk".

Designated Bathing beaches are found at Bray Beach, Brittas Bay South, Clogga Beach, Greystones Beach, Killiney and Silver Strand as shown on **Figure 8.14**. Greystones, Killiney and Brittas Bay are Blue Flag beaches.

A total of 47 water bodies have been designated as being associated with SPAs or SACs (**Figure 8.14**). These consist of 34 rivers, 9 lakes, 2 transitional and 2 coastal. Of these, 22 are considered "At Risk", 15 "Probably At Risk", 8 "Probably Not At Risk" and 2 "Not At Risk".
